Mexican Hat, Utah, Disposal Site

12.0 Mexican Hat, Utah, Disposal Site

12.1 Compliance Summary

SUBJECT: MEXICAN HAT DISPOSAL SITE
OBSERVATIONAL SITE VISIT

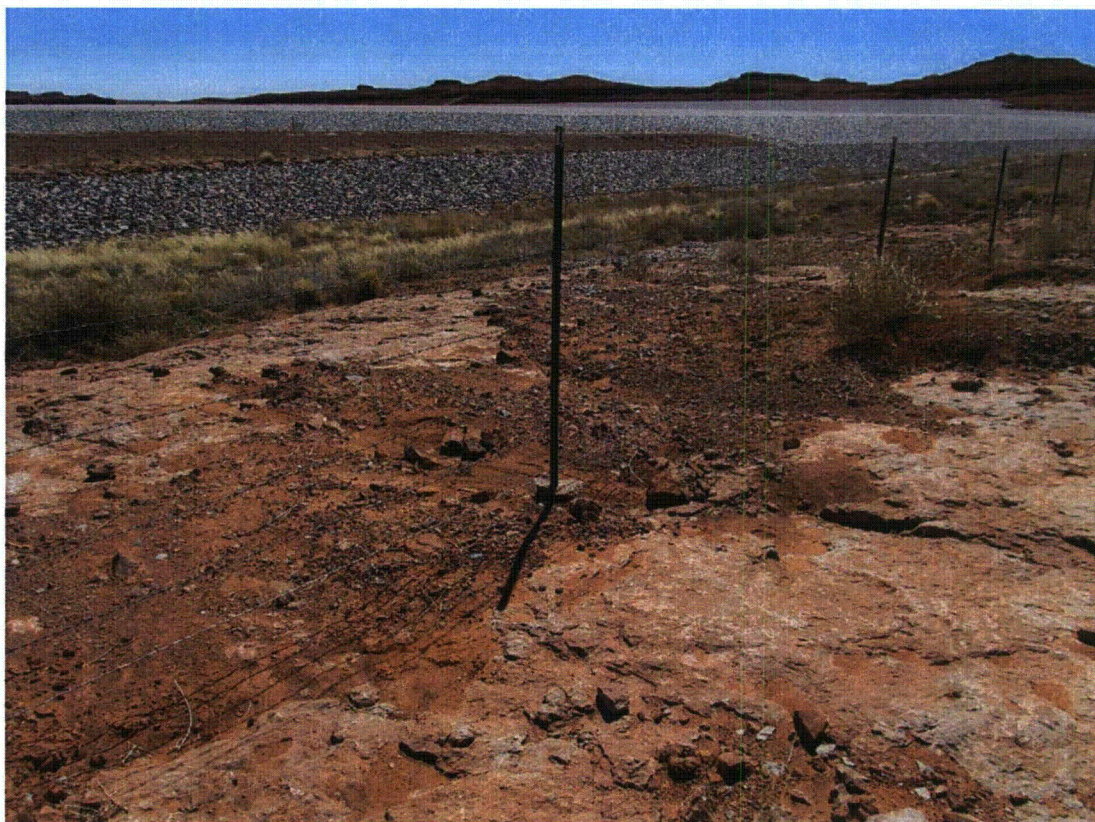
A barbed-wire perimeter fence is located between the disposal cell features and the site boundary. Other than erosion of soil down to rock at a couple of locations near the south and southwest diversion channel, the perimeter fence is in excellent condition. Periodically, the fence is damaged by livestock or erosion and requires repair. Erosion has increased the spacing between the lowest strand and the ground surface between perimeter signs P37 and P40. An additional strand of non-barbed (wildlife-friendly) wire was added in 2010 (PL–1). Erosion continues to migrate up to the end of the west diversion channel at perimeter signs P42 and P43 but is not a concern at this time.

HAT 4/2011. PL-1. New fence strand added to the bottom of the fence in October 2010.

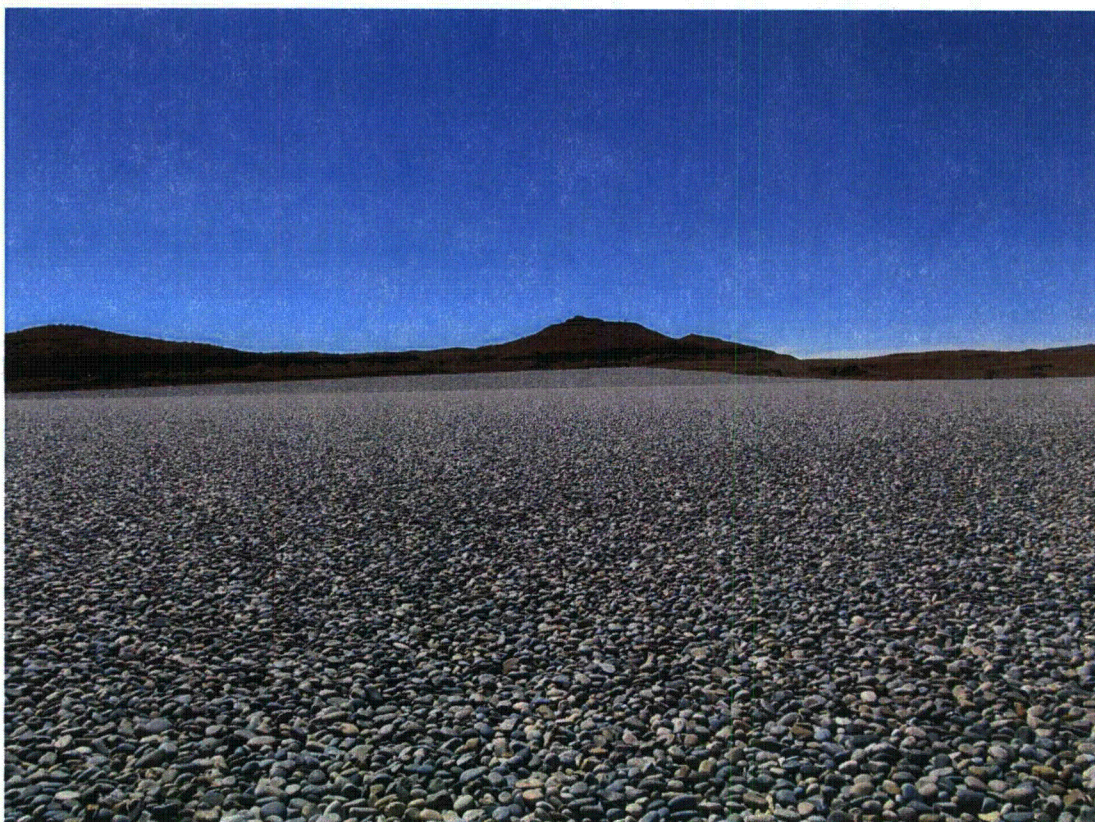
Top of the Disposal Cell—The top of the disposal cell was in excellent condition. There was no evidence of differential settling, cracking, erosion, or burrowing. All visible components of the disposal cell and cover were functioning as designed. No vegetation was observed to be growing on top of the disposal cell (PL-2).

HAT 4/2011. PL-2. Top of disposal cell.

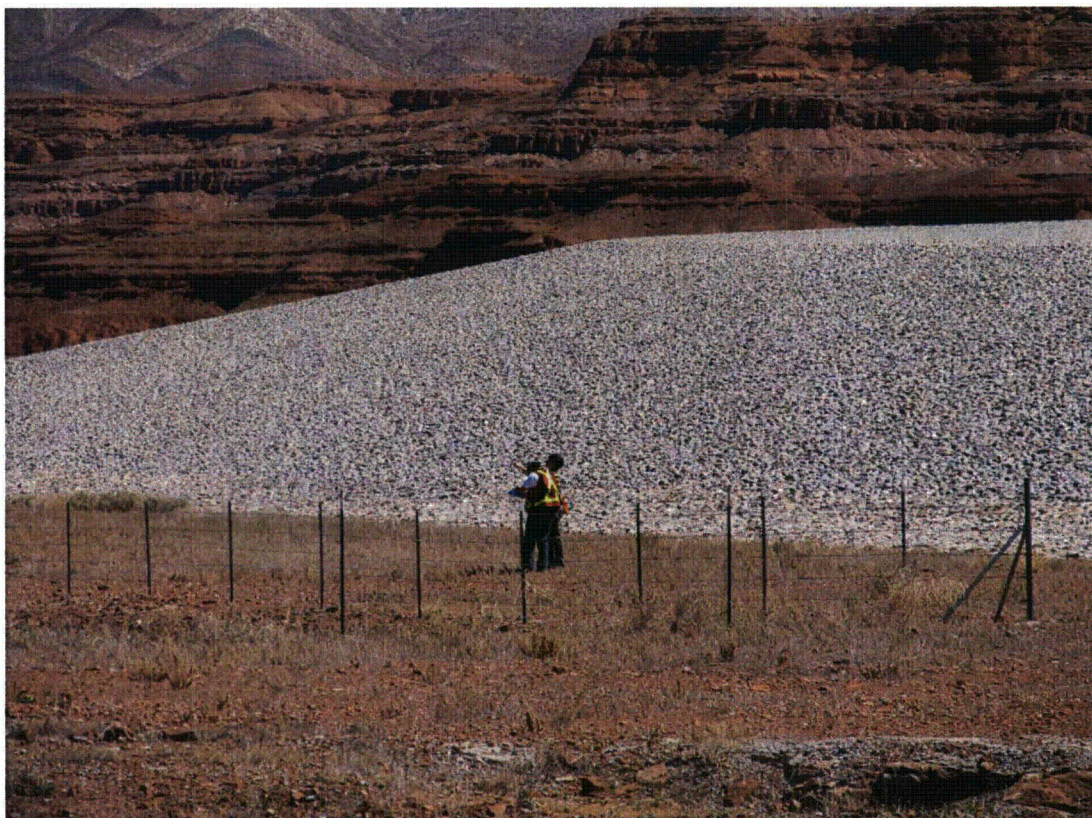
Side Slopes, Toe Drains, Aprons, and Diversion Channels—The disposal cell side slopes, toe drains, aprons, and diversion channels were in excellent condition and functioning as designed (PL-3).

HAT 4/2011. PL-3. Inspectors along the northwest side of the disposal cell.

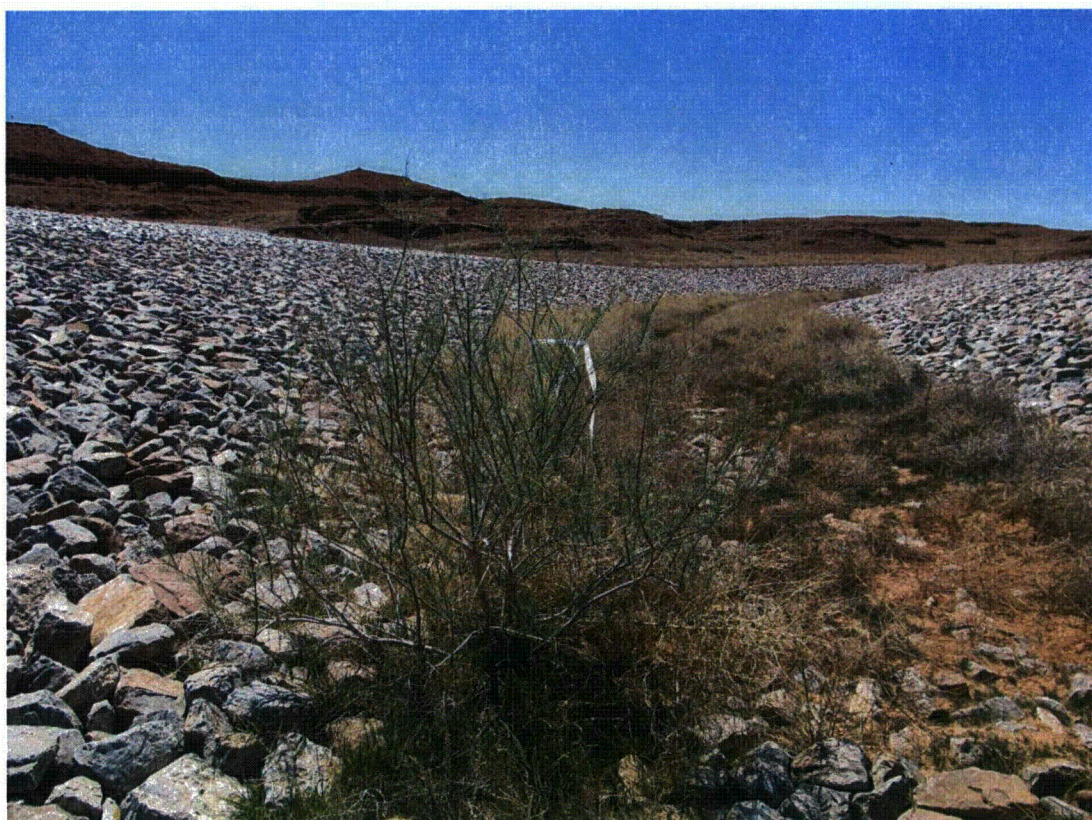
A tamarisk plant was observed on the site during the inspection in the west diversion channel outside of the cap (PL-3). Its growth will be monitored, and it may be removed during the next scheduled maintenance effort. Though present in arroyos outside the site, tamarisk will continue to be controlled on the site.

HAT 4/2011. PL-4. Tamarisk in west diversion channel.

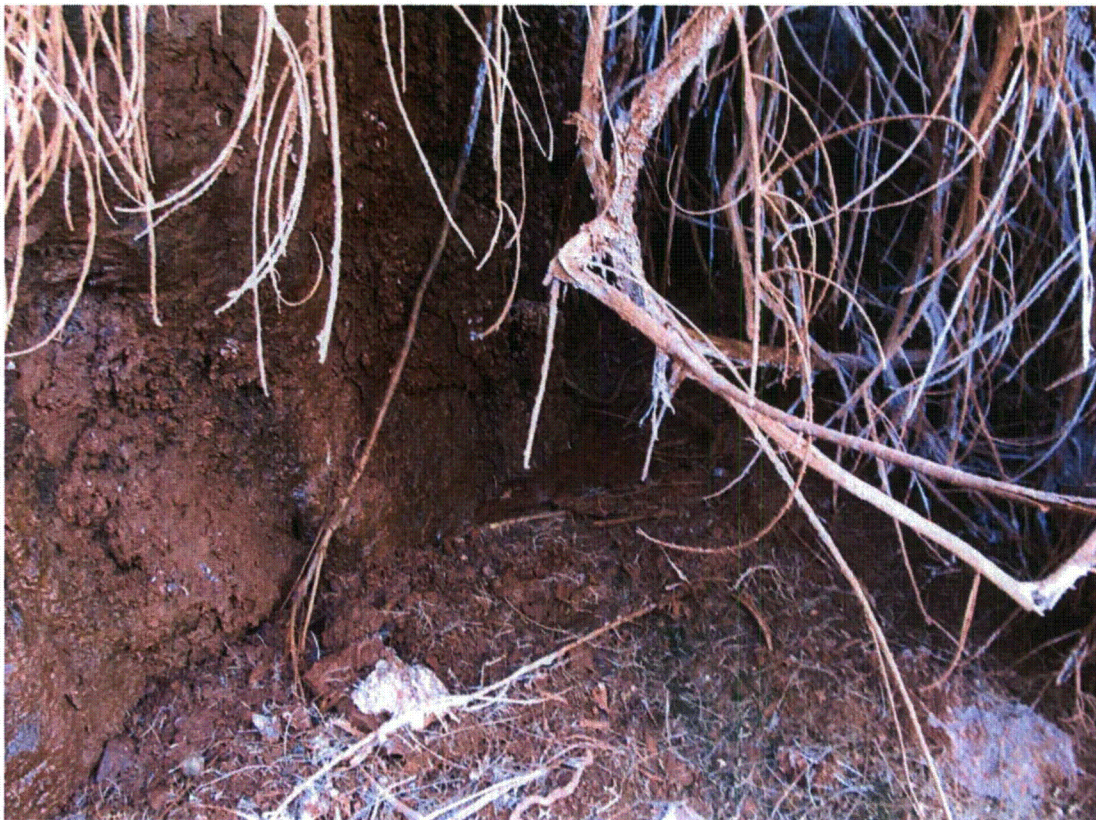
The flow and small pool observed in seep 0248, located in Gypsum Creek and cross-gradient from the disposal cell, were similar to those observed during previous years (PL-4). The remaining five seeps were dry.

HAT 4/2011. PL-5. Seep 0248 dripping with small pool.

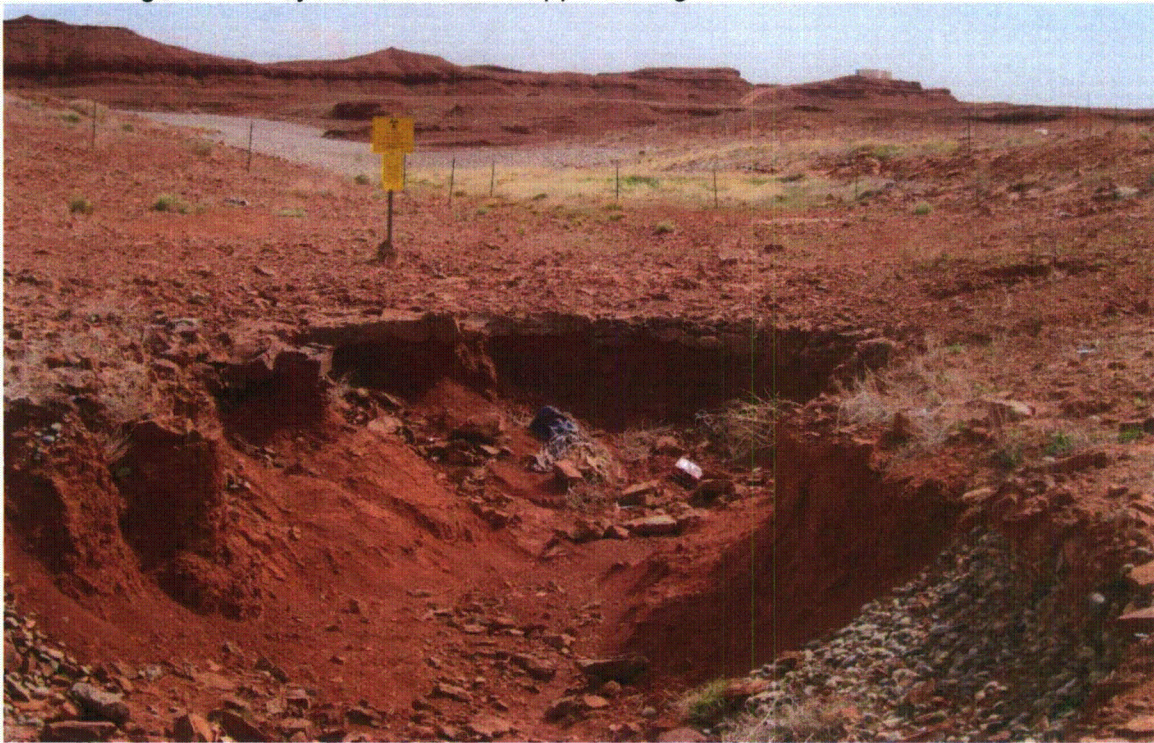
The NRC inspectors noted that the arroyo near the main gate, located on the northwestern side of the disposal cell, was eroding towards the western diversion channel. The NRC staff discussed with the DOE representatives the possible need for intervention at some point in the future. The DOE representatives acknowledged that repairs may be necessary in the future to slow down the erosion. However, the NRC staff concluded that the erosion did not require immediate action, and the erosion did not appear to have a future impact on the disposal cell itself.

Figure 1: Arroyo erosion that is approaching the west diversion channel

The NRC inspectors concluded that the DOE inspectors conducted the site inspection in accordance with LTSP and 10 CFR 40.27 requirements. The condition of the site was nearly identical to the condition that was reported during the previous year's DOE inspection, as documented in the 2011 annual report. The NRC inspectors discussed the erosion of one arroyo with DOE representatives, but this erosion was not affecting the disposal cell. However, DOE may have to address this erosion at some point in the future because it may eventually impact a site diversion channel.
